THICKNESS REQUIREMENTS FOR SOILS BENEATH  
LANDING MATS; BARE BASE SUPPORT

MISCELLANEOUS PAPER S-71-3

# THICKNESS REQUIREMENTS FOR SOILS BENEATH LANDING MATS

BARE BASE SUPPORT

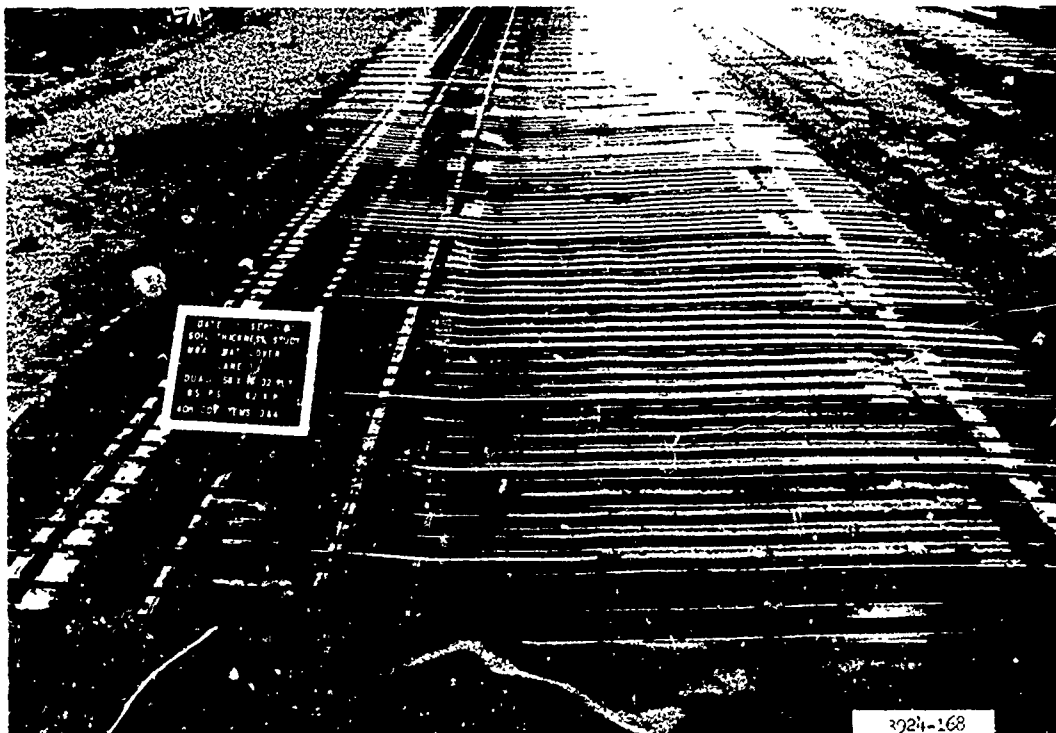
17. Item 3. An overall view of item 3 prior to traffic is shown in photograph A23. Permanent deformation developed slowly with continued traffic. The first mat breakage was observed at 228 coverages. Traffic was continued to 408 coverages, at which time item 3 was considered failed due to excessive roughness. An overall view of item 3 at failure is shown in photograph A24.

Photograph A24. Test section I, lane 3, item 3,  
after failure at 408 coverages

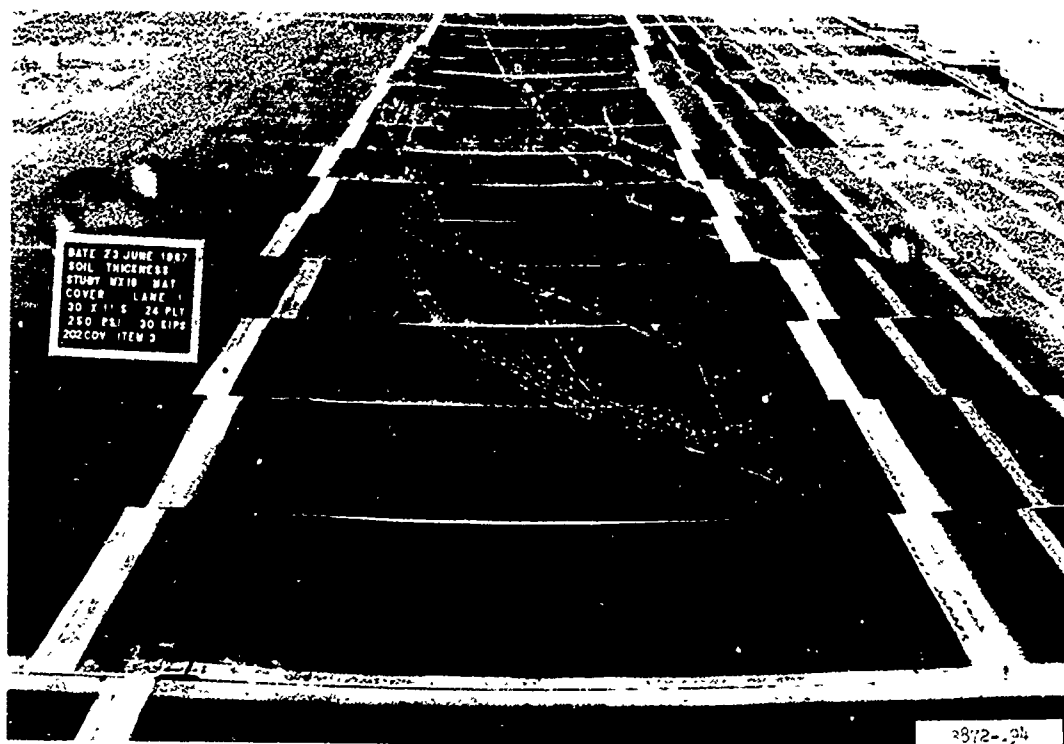
photograph A34. Permanent mat deformation, observed initially after several coverages, increased slowly with continued traffic. By 100 coverages, longitudinal deformation averaged 1.0 in. The first sign of mat breakage, an internal rib failure, was observed at 142 coverages. After 202 coverages, item 3 was considered failed due to excessive roughness caused by subgrade deformation. An overall view of item 3 at failure is shown in photograph A35.

Photograph A35. Test section II, lane 1, item 3,  
after failure at 202 coverages

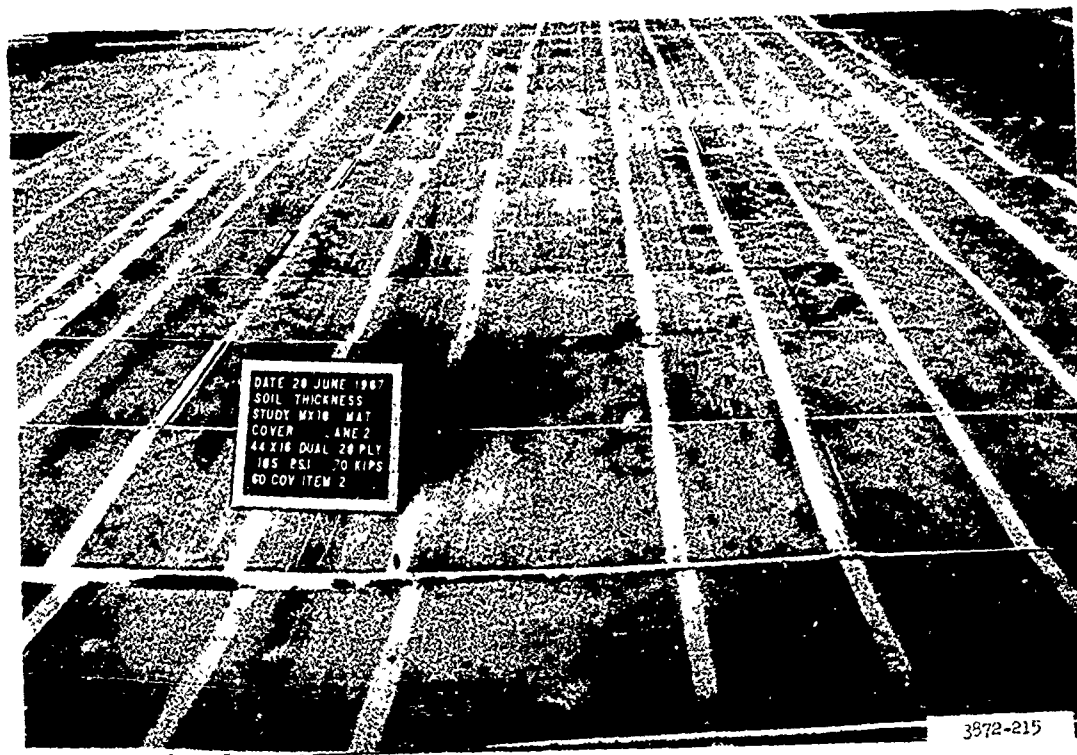
29. Item 2. An overall view of item 2 prior to traffic is shown in photograph A41. Longitudinal deformation measured 1.13 in. after 32 coverages. Mat breakage was first observed after 48 coverages. The bottom lip of an overlapping end joint had sheared on one panel, and two panels had disconnected along the C-rail and male connectors. Item 2 was considered failed after 60 coverages due to excessive deformation and mat breakage. Photograph A42 shows a typical overlapping end-joint failure. An overall view of item 2 at failure is shown in photograph A43.

Photograph A43. Test section II, lane 2, item 2,  
after failure at 60 coverages

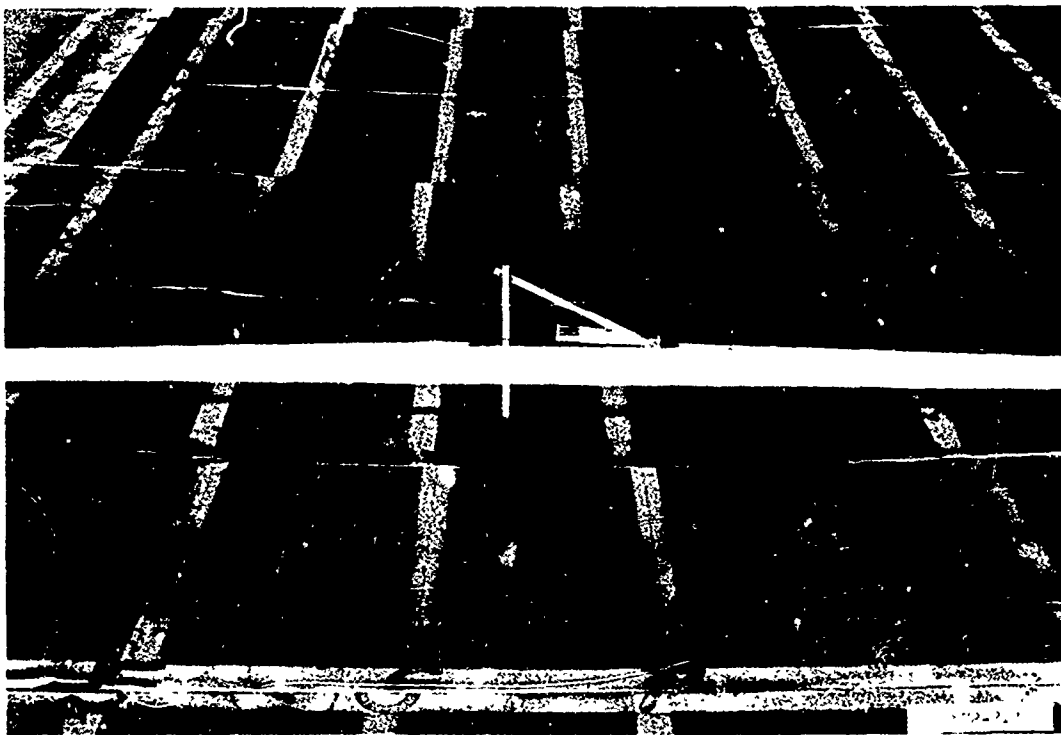
Photograph A46. Longitudinal deformation of 3.1 in. after 144 coverages
